Australian Government
Department of Defence
Defence Science and
Technology Organisation

Development of a Hard-Patch Approach for Scarf Repair of Composite Structure

DSTO-TR-1892

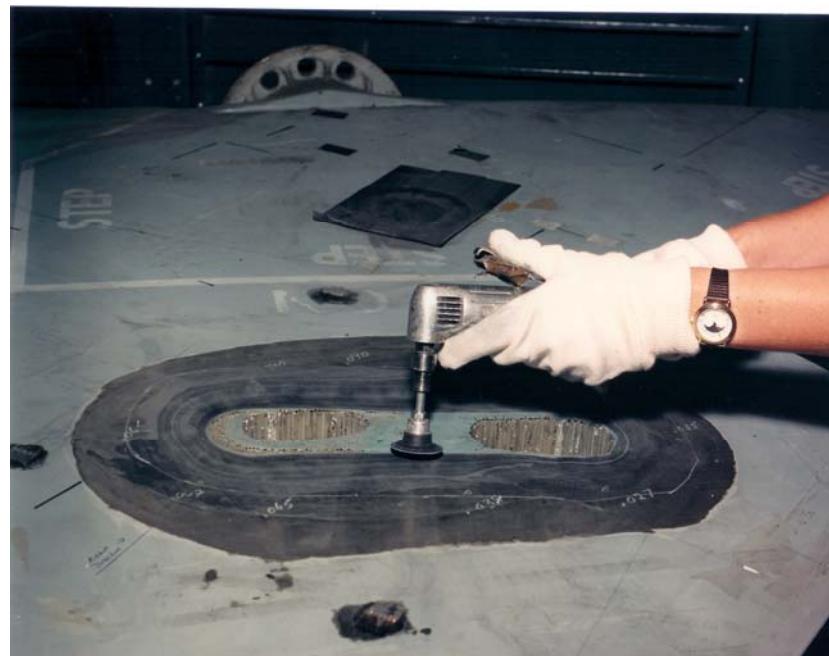
The manual method was used by USN for forming the scarf in the stabilator, involving use of a hand-held pneumatic router or grinder, Figure 3.

Figure 3: Formation of the scarf in the F/A-18 Horizontal Stabilator using a hand-held router

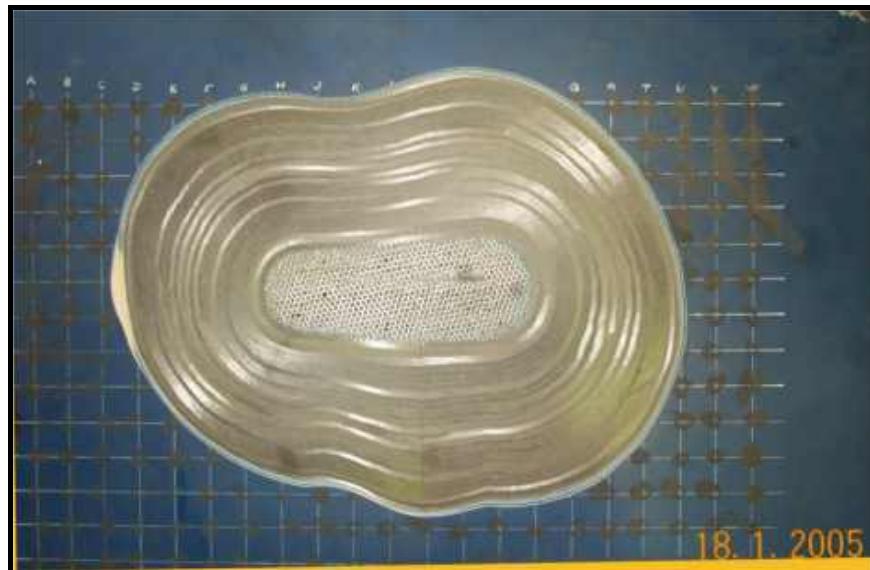
The final contour of the cavity (perimeter) was not a regular oval shape (Figure 4). This was due to the irregular curvature of the surface and the variation of the skin thickness.

Figure 4: CNC Machined scarf cavity

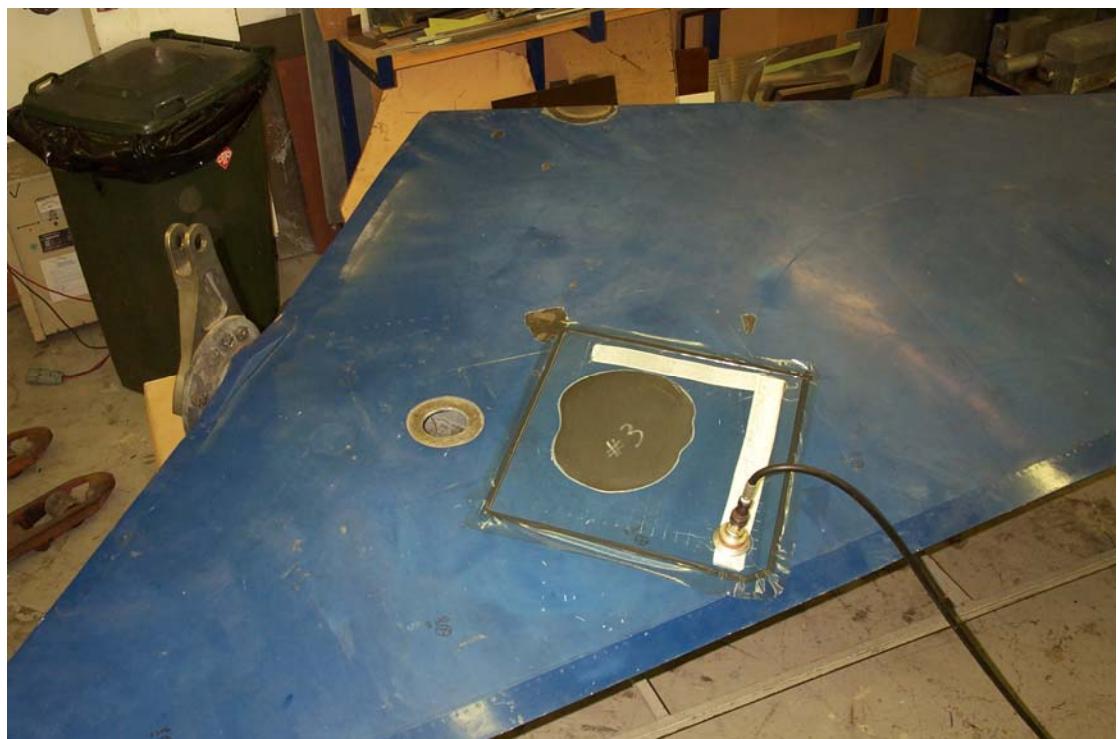
The fit-up of the finished patch was evaluated using a simple vacuum-bag assembly as shown in Figure 8. It was found that fit up was excellent, with no gaps or distortion. The distortion of the patch is easily removed at RT under vacuum-bag induced pressure; furthermore, distortion would be considerably reduced at the patch-bonding temperature as residual stresses would be much lower at 120°C- they would have been zero at 180°C.

Figure 8: Stabilator showing patch under a vacuum bag for evaluation of fit-up

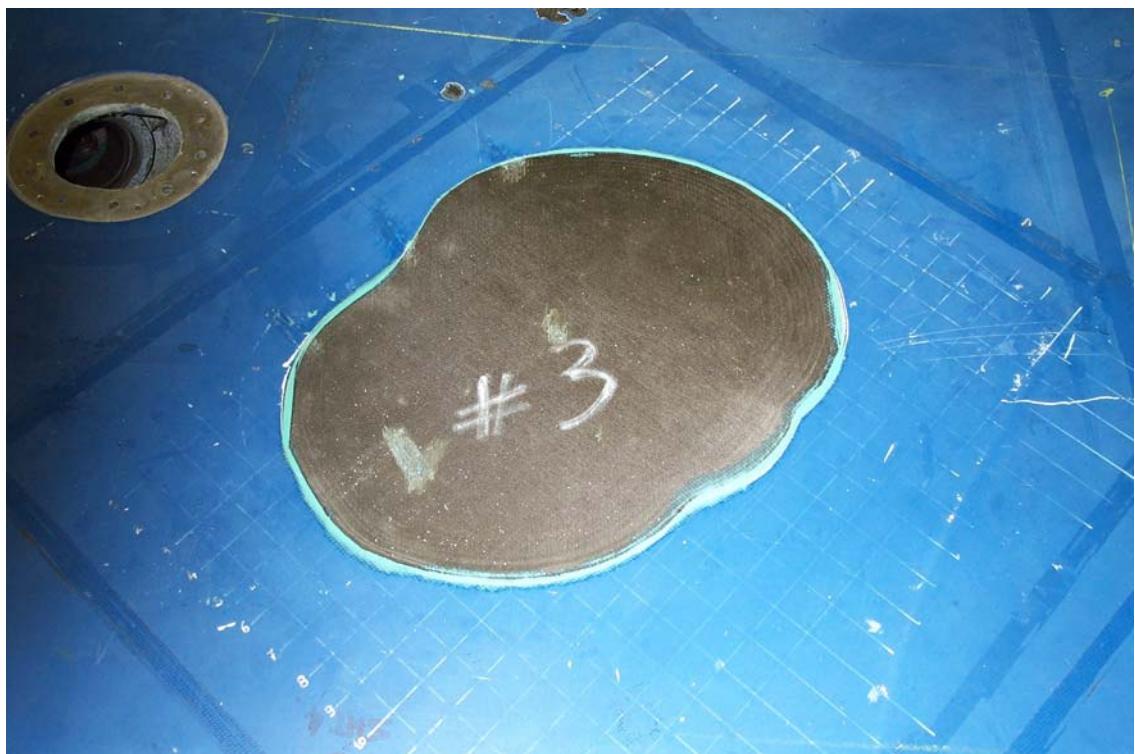
Following satisfactory evaluation of fit-up, the patch was lightly grit-blasted along the bonding surface and assembled with adhesive FM 300 under a conventional vacuum bag assembly, with thermocouples monitoring and controlling the cure cycle. Cure temperature was 2 hours at 120°C under a slightly reduced atmospheric pressure. The resulting repair region is shown in Figure 9.

Note that doubler plies were not included in the repair. However, they could have easily been pre-formed and co-bonded with the patch if required. Generally, a doubler is required to protect the scarf tips and improve tolerance to damage. In this application they were not included to demonstrate the fit and very low surface profile of the repair possible from the moulded hard-patch technique.

Figure 9: Patch bonded to HS
